5.4 Ontario Street, west side

**16 and 18 Ontario Street**

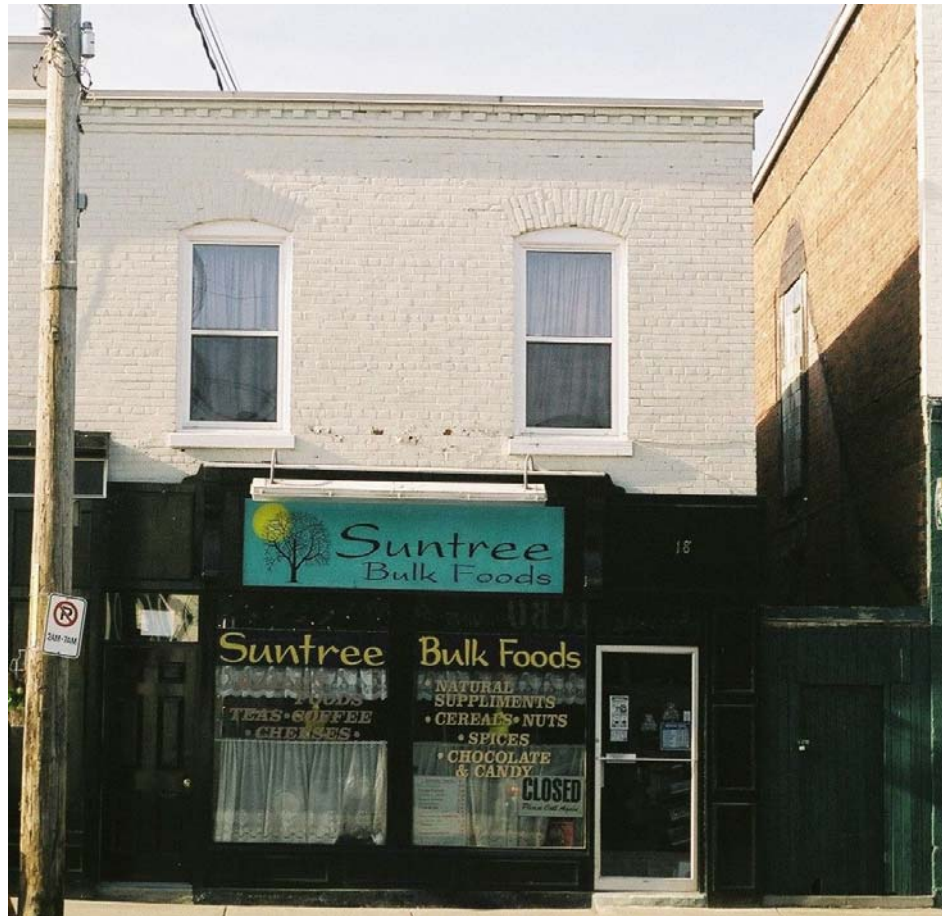
- Two-storey, painted red-brick building with recent, Post Modern shopfront (c. 1880).
- East Elevation – Modest commercial Main Street building has recent, aluminum-framed shopfront apparently reworked in Post Modern idiom, with extensive use of plywood and planted mouldings. Masonry to either side is clad in plywood with planted mouldings in varying configurations. Entry to upper flat (at left) has modern 6-panel (i.e. Georgian) door, while shop door (at right) is standard, glazed aluminum unit Shopfront glazing consists of two large panes with wood-clad mullions, set above stall-riser clad in plywood, with applied mouldings forming panels. Very deep fascia above comprises framed panels to either side of large consoles which, in turn, frame new cornice with profiled sections under dentils.

- At second floor, wall is built of painted red brick (assumed to be without polychromy), with headers typically every sixth course. Windows are two, 1/1 aluminum replacement units, retaining wooden sills (RH unit is visibly repaired), and are set within segmental arches.

- Parapet is of painted red brick (again assumed without polychromy) and consists of two corbelled courses, course of separated, corbelled headers and additional double course of corbelled masonry above, capped with galvanized metal flashing.

- Comments – Modest main-street building is much altered at shopfront, but older elements appear to remain behind and above Post Modern signage and trim. These should be investigated. Recent installation of planted mouldings on plywood appears at first suitable to the historic context, but these could be improved and a more suitable period-type shopfront might one day be installed. Brickwork has presumably been painted because of spalling at upper levels. This should be investigated and water ingress, or humidity migrating though wall, should be prevented. Ideally paint should then be carefully removed from bricks. Loss of original windows at second floor, presumably with curved upper sashes, is unfortunate.
