### 5.5 John Street, east side

#### 17 and 19 John Street

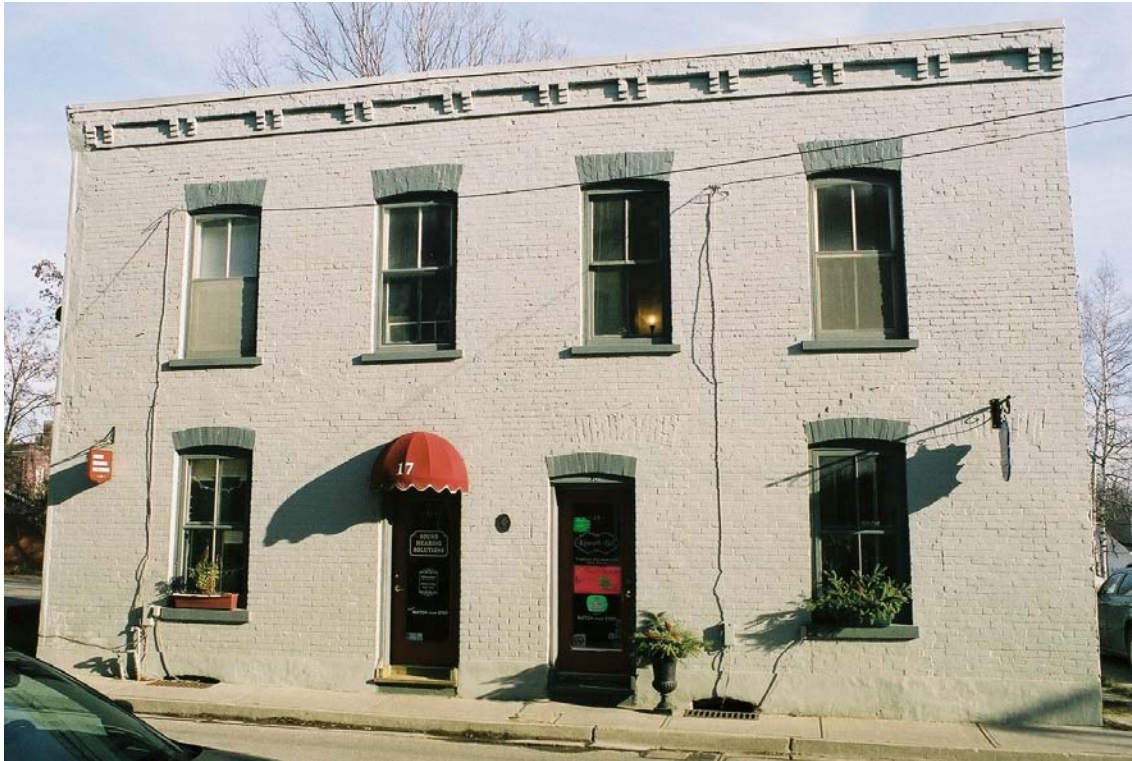
- Pair of attached, two-storey, flat-roof (painted) brick houses with corbelled parapet (c.1880). Buildings are **Designated** under the Ontario Heritage Act, Part IV.

- West Elevation – Modest pair of brick houses, with flat roof behind brick parapet, is typical of its genre, though unusual within John Street. Base of wall is cement-rendered, presumably over brick. Two different iron grills in sidewalk indicate basement windows below segmental arches. Painted brickwork is laid in common bond throughout. Front doors are centrally located and are recent, fully glazed, vinyl doors. At no. 19, voussoirs of two older arches remain – one above door and one near RH corner – indication former apertures. Ground-floor windows are 2/2 units with segmental-arch top rails (behind 4-pane wooden storms). Sills are wooden and segmental arches are built of single row of soldier voussoirs. At second floor, four 2/2 windows (as at ground floor, but with framing for metal storms) are evenly spaced across wall, with sills and lintels as described. Voussoirs are taller here, extending to brick-course five joints above. Parapet consists of stringcourse, paired brick corbels at approx. four-foot intervals, and an additional five brick courses above. Top of parapet, which seems roughly built and low, is flashed in painted sheet metal.

- North and South Elevations are rendered, possibly over soft brick at former party walls.
- East Elevation (at rear) is built of (painted) brick at ground floor and clad in cove-type clapboard at upper floor. Modest, one-storey, lean-to addition straddles property line, and is clad in horizontal vinyl siding. Rear elevation contains a number of 2/2 windows, typically behind wooden storms.

- Comments – Brick houses are in good condition and retaining old windows, though locations are altered at ground floor, which may account for painted masonry. Evidence of rebuilding at lower level includes altered masonry and simpler voussoirs. Brick is assumed to be red brick throughout and if so, should be painted a similar colour. Parapet seems to have been reduced – historic photos may confirm this – and if so, rebuilding is to be encouraged. Wooden storm doors and one lower wooden storm window have recently disappeared. For possible development of parking lot to north, see the Guidelines.
