5.1 Queen Street, east side

27 Queen Street

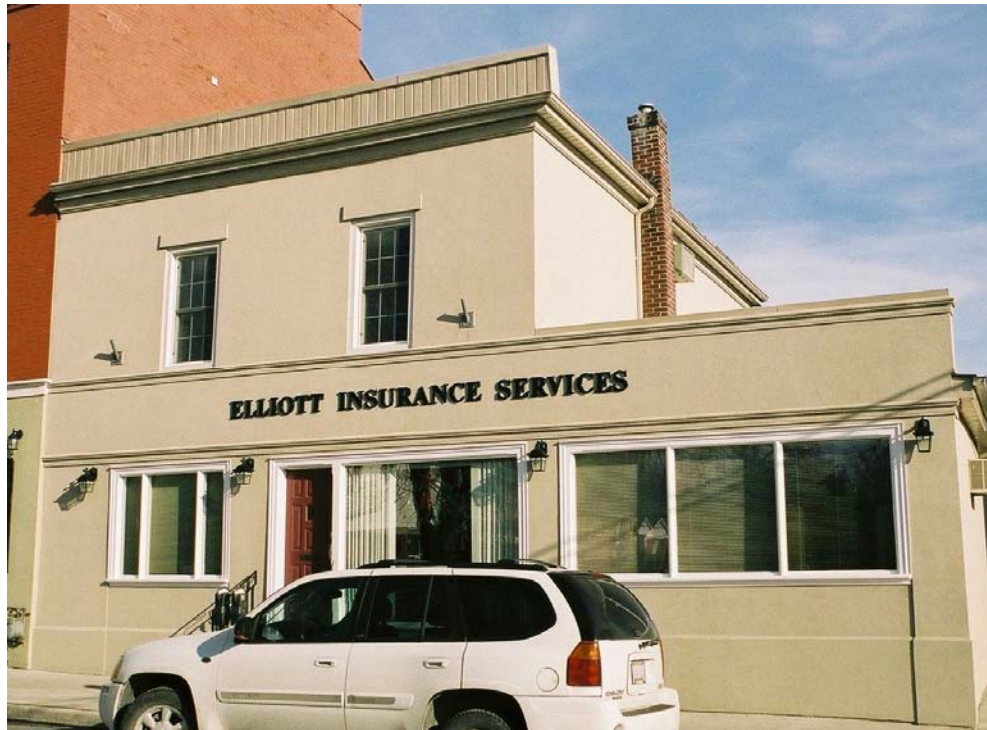
- Two-storey, stuccoed, apparently recent building, with one-storey south block (c.2000).
- Front Elevation – Stuccoed (E.I.F.S.) building seems to be new, except for unusual asymmetry, and older brick chimney at south wall. Entrance is located near centre of two-storey block, reached by small flight of concrete steps with ornamental metal railings either side. Front door is modern, wooden, nine-panel door with small window. Modest wooden casings extend at right to frame also very large, single-pane window. To left of door is triple-sash window with wider central unit, framed as door, and with thin wooden sill. One-storey south block has fenestration comprising three large, single-pane sashes with trim as described. Building is lit by four heritage-style lanterns at ground floor. Deep stucco fascia, framed by identical top and bottom mouldings, extends across entire building, forming signage band for attached, individual letters. At second floor are two, new 6/6 windows (with false muntins), set within aluminum-flashed frames. Wall is without decoration or trim, though both windows have slightly projecting lintels. Wall-head is capped by fascia with profiled bottom edge, shallow wooden soffit and wooden fascia with modern aluminum gutter. Front parapet rises some two-feet above gutter, clad in vertical vinyl siding and capped by deep flashing.

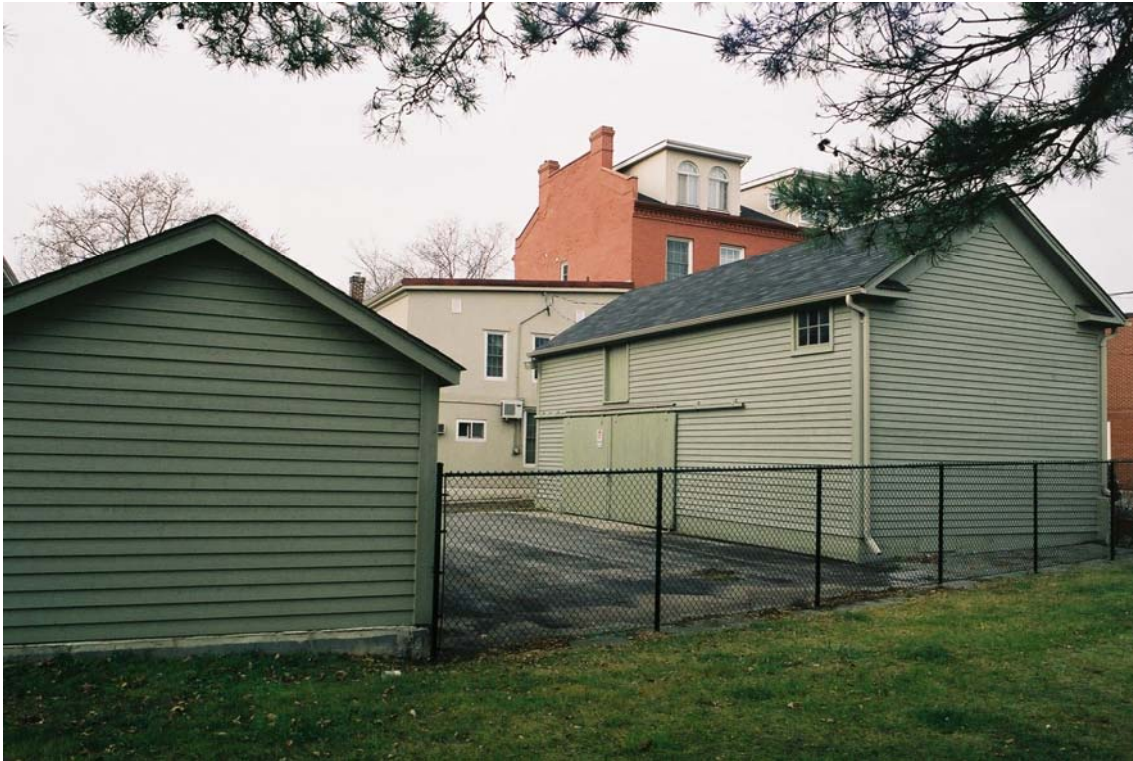
27 Queen Street (continued)

- Side and Rear Elevations – Side elevations are also stuccoed, with second-floor soffits wider than at front, and with central, single-vent, red-brick chimney having re-built head.

- Outbuildings - Two clapboarded, pitched-roof structures, one a recent small garage and the other a larger, older building, are set at rear of lot and plainly visible from Rotary Walkway. Larger structure has traditional, returned eaves and deep fascia at gable, as well as old, 6-pane sash at upper RH south side, and sliding doors beyond to the left. Cladding is somewhat inappropriate, being rough-sawn wood different from traditional cladding in appearance.

- Comments – Modest stuccoed building is an unusual presence on Queen street, and within the brick-built, Heritage District. Structure appears to be new, though asymmetry is unusual in a modern building, and brick furnace chimney at south wall is evidently older than rest of visible wall surfaces. Projecting lintels, front parapet and differing depth of eaves all suggest that two-storey volume is a re-worked older building, though recovery of the original forms and materials may no longer be possible. At rear, old, pitched-roof clapboard shed, with traditional details at gable and old window, is an attractive and interesting presence within back lane, and more recent, pitched-roof garage has a traditional form. Removal of chain-link fence and incorporation of larger building into some new, back-lane/riverside use addressing Rotary Walkway would be a positive development.
