5.6 John Street, west side

**46 & 48 John Street**

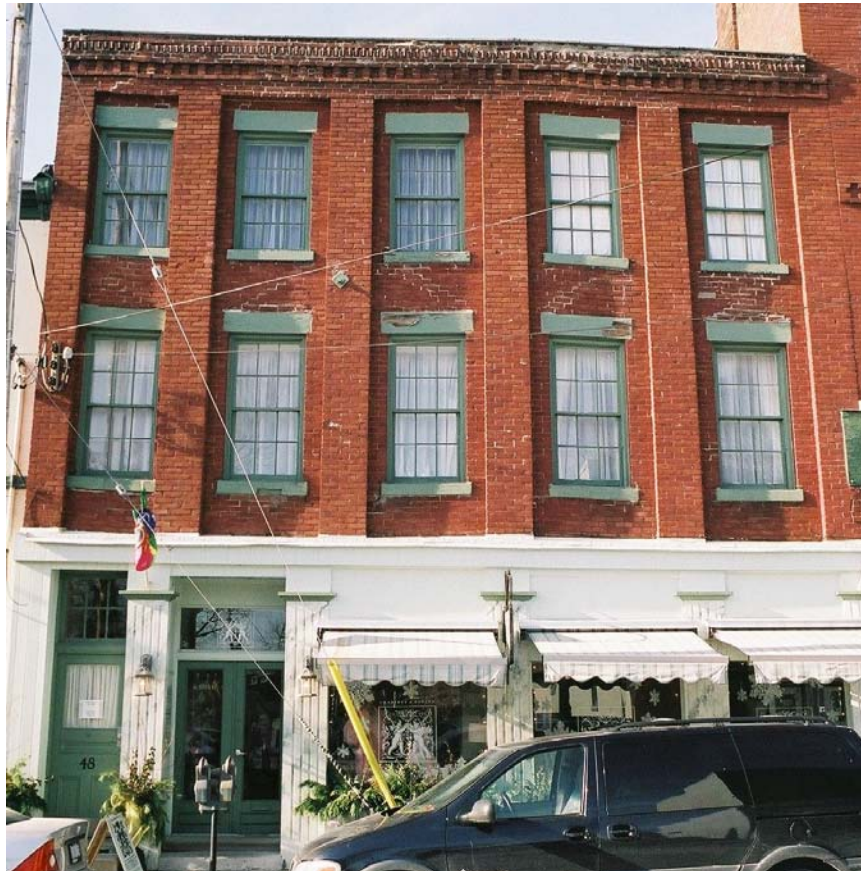
- Three-storey, 5-bay, red-brick building with original 6/6 windows, wooden lintels and sills (c.1860).
- Ground Floor – Rhythm at street level differs somewhat from that of upper storeys, due to doors at LH side. Bays are divided by recent, grooved pilasters (assumed to have brick piers behind), with modest cap mouldings towards tops. Three large, recent, shopfront windows at RH side have planted mouldings on plywood panels at stall risers. Large painted panels above may indicate older shopfront glazing behind. Doors to shop (no. 46) are recent, glazed wooden doors under recent decorated transom window, with old, two-pane, shop-window in recess to right. Door to upper floors (no. 48) is old, half-glazed, three-panel wooden door with bolection mouldings, under old six-pane transom window. At top of ground floor, band of vertical v-jointed boards replaces a cornice.

- Upper Floors – Second and third floors are divided into five bays by simple, full-height brick pilasters. Windows are all old 6/6 units without secondary glazing, and with painted wooden sills and lintels. There is much settlement at these levels, withj commensurate re-pointing in spandrel panels. At top within each bay, upper wall is built out to meet plane of pilasters. Parapet comprises dentil-like band of stacked brick headers between lower and upper stringcourses, and band of cut-down, dog-toothed soldiers above. Wall-head has two more courses and is capped with discreet sheet-metal flashing. There is again much settlement, and some over-pointing, throughout this level.

- Rear Elevation – Lane elevation retains original 6/6 windows, in wall with considerable settlement.
- Comments – Brick building is generally in good repair, but has suffered from significant settlement, now assumed to be inactive. (Note also bulging masonry behind RH pilaster.) Ground-floor shopfronts are not in keeping with period types, including use of vertical v-jointed boards, but post-modern rather than modern. When alteration is contemplated, these should be replaced using suitable forms and materials, perhaps replicating an older shopfront if period photos are available. At upper levels, original windows and wood lintels and sill are charming features, and painting is required. Similarly, all old 6/6 windows should be retained, maintained and repaired as necessary.
