## 5.5 John Street, east side

## <u>49 John Street</u>

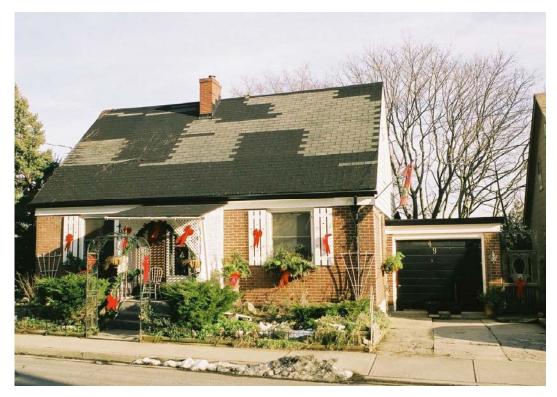
- Symmetrical, 1<sup>1</sup>/<sub>2</sub> storey, red-brick Cape Cod house with flat-roofed garage (c. 1950).
- <u>Description</u> Ground floor <u>masonry</u> is of common-bond red brick over roughly formed, castin-situ concrete foundation. Modest <u>lean-to porch</u> with over small landing is enclosed at sides and part of front by painted lattice-work. Old <u>front door</u> has four vertical lower panels with attractive multiple-pane glazing above (behind glazed storm door). <u>Windows</u> at either side are wide, 1/1 units (behind metal storms) framed by later, plank-type shutters. Sills are canted rowlock headers and lintels are concealed by aluminum siding below eaves. Soffits are minute and aluminum-clad, as is fascia. Unusual metal hopper exists at RH side, feeding corrugated metal downspout. Steeply pitched <u>roof</u> is clad in black asphalt shingles, with various areas repaired with light-grey shingles. <u>Garage</u> at south side has flat roof and is apparently a later addition, built also of red brick, with single-car door formed of nine fullwidth metal panels. <u>Gable walls</u> have windows and sills etc. as described (behind metal storms) at ground and second floor levels. Gables are clad in textured vinyl siding, presumably over clapboard, with small moulding at eaves.

- <u>Comments</u> Modest house is later than majority of structures within block, but still has
  traditional elements of pitched roof, red brick masonry and double-hung windows. Front door
  is surprisingly ornate. Removal of recent, textured siding at gables is encouraged, assuming
  that wood siding in good repair exists beneath. Flat-roof garage is a foreign addition, though
  not unacceptably so. Extensive plantings of front garden is unusual in the Heritage District,
  but not unsuitable given more recent and suburban nature of this house.
