5.5 John Street, east side

51 John Street

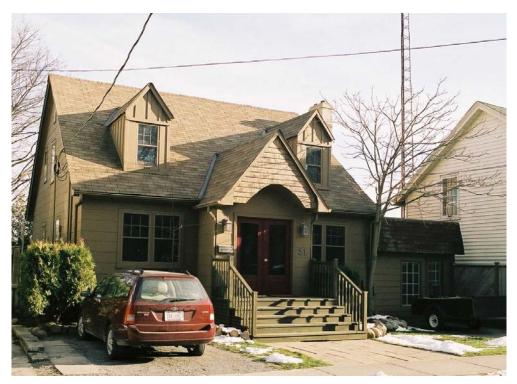
- Symmetrical, 1½ storey Arts-and-Crafts style house with gabled porch and dormers (c.1950).
- Description Modest, pitched-roof house is dominated by projecting entry. Broad flight of wooden stairs is built of modern lumber sections and recent railings have turned spindles typical of interior balusters, while newels and handrails are plain. Pair of ¾-glazed front doors with planted lower panel have modern, commercial aspect and are trimmed with modest casings. Front gable, with arched opening, is clad in cedar shingles, and has shallow eaves, plain soffits and narrow, plain fascias. Front windows are paired, 6/1 units at either side of porch, with narrow sills and casings, and with single-pane wooden storms. Wall cladding is painted, fibre-cement tile set at large reveal, each tile having slightly wavey lower edge. Older material (clapboard or render) may lie beneath fibre tiles. Steeply pitched roof is clad in brown asphalt shingles, with tall dormers over ground-floor windows. Tall, narrow dormers seem to be later additions, also with 6/1 windows (with 2-pane storms), shallow eaves and narrow fascias. Dormers appear to be clad in plywood with wide battens over, giving faintly neo-Tudor aspect to upper level. Gutters and downspouts are, respectively, in traditional ogee and corrugated profiles, and a double-vent chimney exists at south gable.

- <u>South addition</u> has flat roof behind small mansard and seems now to house separate commercial function, but was probably built as a garage. Addition has single sash, fixed window with false, 12-pane muntins and modern, 15-pane French door to right (behind metal storm). Front wall is clad in horizontal aluminum siding, with brown asphalt shingles above.

- <u>Gable walls</u> North gable wall has two, symmetrically placed 6/1 windows at ground floor and similar but different-sized windows above. Cladding is again fibre-board shingles. <u>Soffits</u> have plain wide boards with large moulding at wall-head, and plain narrow fascias.

- Comments Attractive house is of relatively recent origin but is built generally in keeping with early twentieth-century practices. Window, door and mansard roof at south addition could be reworked to fit better into heritage context. Dormers are somewhat out of character with house, but a two-tone paint scheme might enhance these. Fibrous shingles may hide older material, or may perhaps be original. Double doors suggest commercial occupancy and so are suitable in this Transitional Residential Sector for a house converted to a new use.
