### 5.6 John Street, west side

#### 76 John Street

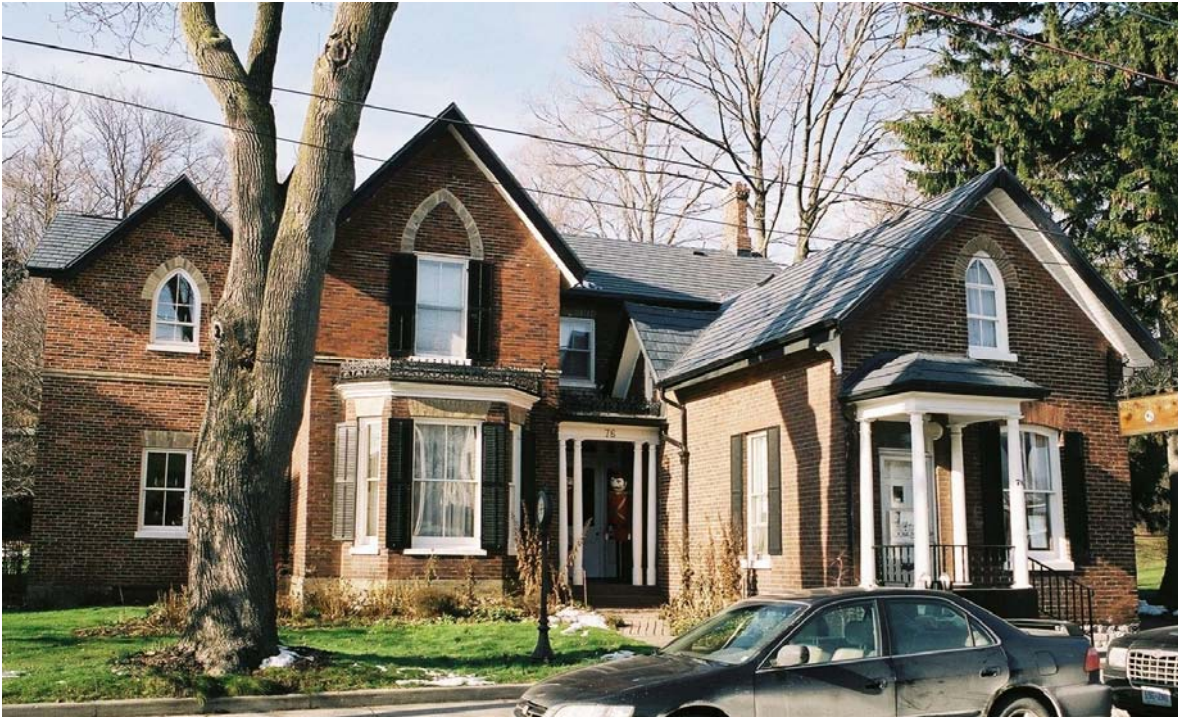
- Dichromatic, two-storey, gabled Victorian house with additions to east and south (c.1870 ff.)
- Original House – Large Victorian house has entry tucked into recess to right of bay window. Porch has sandstone step and landing, and pair of replacement columns support metal-clad pitched roof, with iron cresting at base of slope. Attenuated columns, with entasis, have elongated cylindrical bases with incised upper ring, extending to more typical base, while at top echinus and abacus are closer to traditional norms. Entrance consists of central, half-glazed, coloured-glass door with 3 tall, segmental-headed lights over single panel with wide bolection mouldings. Sidelights are similarly glazed. Glass exists in blue, ochre and umber, with patterns on inside of panes. Mullions and transoms are finished with robust roll-moulding, halved adjacent masonry, and three transom windows have clear glass, with Saltire at central unit. Single 2/2 window (with metal storms) above roof has wooden sill and buff-brick voussoirs at flat-arch. Projecting, gabled block to left is built of red brick, over stone foundation and buff-brick plinth with bevelled top course. Ground-floor bay window has central 2/2 window and 1/1 windows at side, all with wooden sills and flat-arch, buff-brick voussoirs. Louvred wooden shutters are operational and appear authentic but are too narrow for apertures and unlikely on Victorian house. Wall-head has thick wooden cornice, with cast-iron cresting masking metal-clad hipped roof behind. Second floor above has double-course, corbelled buff-brick stringcourse and consists of red-brick masonry with central 1/1 window having sill and shutters as described. Blind pointed arch above is built of tapered, buff-brick voussoirs framing red-brick tympanum built over narrow wooden lintel.

- South Addition - Recent gabled addition matches original house, with similar masonry, typical 2/2 window (without shutters) at ground floor, and pointed-arch, 2/2 window above, rising into gable. South wall contains huge, two-storey window of semi-ecclesiastical nature, with various sash types.

- Fascias and Roofs – Soffit boards are beaded throughout, and wooden fascias have beaded lower edge and deep shingle-mouldings. Roofs are clad in textured, interlocking metal shingles. Gutters are conventional, aluminum profiles with iron hoppers below eaves. A two-vent chimney, in good repair, exists at north end of main roof peak, with base having bevelled top course, chamfered bricks at corners, and with corbelled and dog-toothed bands in lower courses of chimney-head.

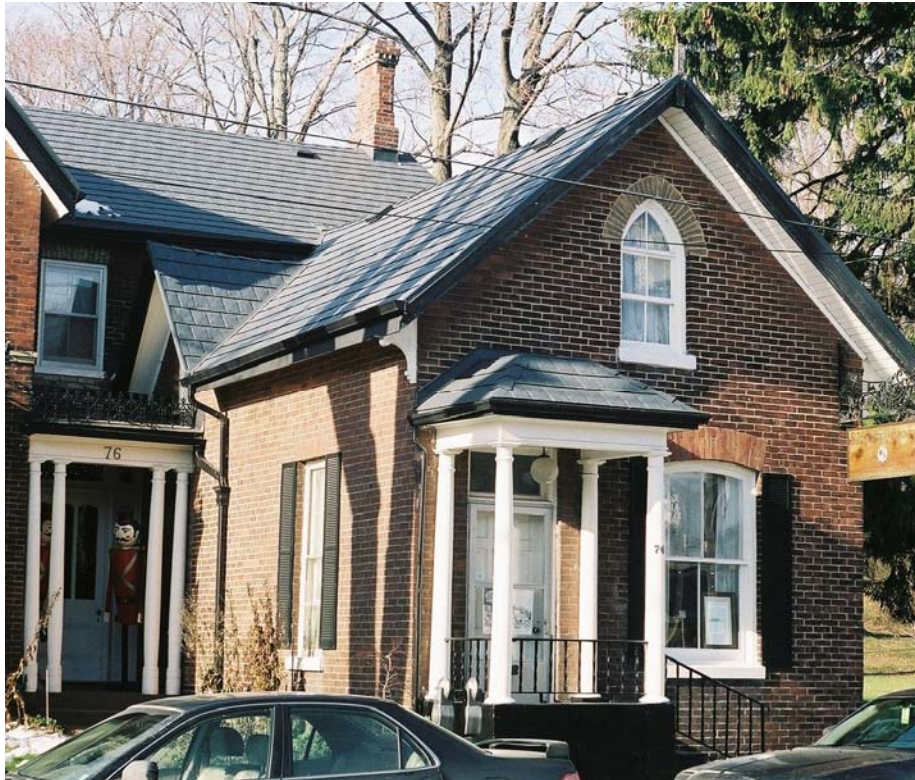
**76 John Street** (continued)

- East Addition - Gabled addition at right is later (c. 1880?) than house behind, as testified by butt-joint in brickwork to right of front door. Red-brick masonry is in common bond at front, and with headers every sixth course at sides. Porch has steps and landing rebuilt in concrete, with four traditional, full-height, turned wooden columns rising to peripheral beam with typical upper and lower mouldings, and hipped roof above. Front window, to right, is 2/2 (with fixed modern shutters) having wooden sill and segmental-arch head with buff-brick voussoirs. Upper level has 2/2 unit and two-pane transom window in pointed-arch aperture as at central gable, with unusual, thick roll-moulding at transom. Wall-head is finished with modest moulding, and front eaves have decorative wooden bracket either side under projecting, v-jointed fascia boards. Small king-post at peak is assumed to be remnant of gable finial. At south elevation, ground floor has 4/4 window (with metal storms), and small, 2/2 window at second-floor dormer beyond.

- Comments – This is an attractive, authentic and, because of the different periods of construction, an interesting house, all in excellent repair. Alterations to front porch are slightly incongruous but tastefully executed, and recent addition to south is convincing, with huge window visible only from south side. Addition in fact serves as good example for new work within the Heritage Conservation District. Roofing material is unsuitable, and original material should be investigated and perhaps one day be reinstated. (Remnant of original material may remain where peak of addition meets front pitch main house; or nail patterns or old photos may indicate this.) House may originally have had no rainwater goods, but installation of more robust, period gutters downspout profiles, would be an improvement. Only metal storm window at front elevation is above front entrance and this should ideally be replaced with a wooden storm instead.
