5.5 John Street, east side

41 John Street

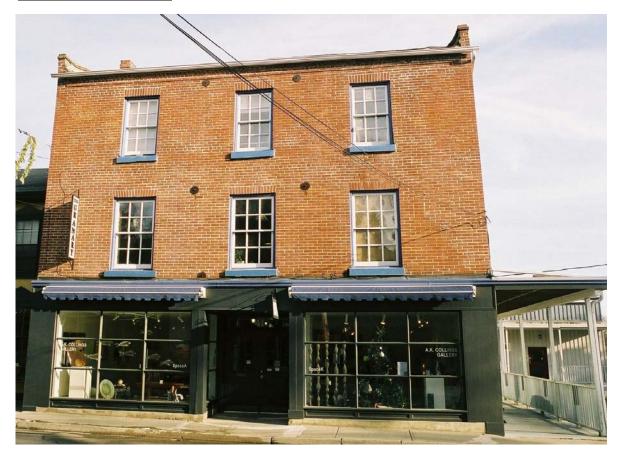
- Three-storey, red-brick Georgian commercial building with large addition at rear (c. 1860s).
- Description Ground floor has large, 9-pane shopfront windows and recessed central entry, framed by plain plywood pilasters at outer piers, narrower wooden pilasters at centre, and deep, plain wooden fascia spanning full width of building under modest cornice. All elements appear to be recent, especially exposed concrete foundation below, which has three small wooden panels forming tiny stall-rise. Entry consists of pair of half-glazed, modern doors with two stamped panels below and nine panes set in vinyl muntins. Single-pane transom window spans full-width above. Second and Third Floors are built of red brick, laid entirely in common bond at second floor, and with headers every eighth course above. Upper floors each contain three replacement 6/6 windows with unusually wide muntins (framing individual thermopanes), set over thick wooden sills. Arches are virtually flat, built of single course of soldier voissoirs. Several circular iron plates indicate presence of metal ties and suggest previous problems of movement in the masonry. Wall-head is crowned by slightly projecting double-course with dog-toothed band above. Pitched roof, invisible from street, drains to conventional aluminum gutter. Tall, unflashed brick parapets at either side are built of brick laid to follow slope of roof, rising to modest, multiple-vent chimneys, with projecting doublecourse near chimney heads, which exist near roof ridge at both sides.

- <u>South elevation</u> (see photo on next page) consists of gabled brick wall built of red brick with header bands every several courses, has two recent, 6/6 windows at second floor (as described above), with soldier-course voussoirs forming flat arch at what appear to be later apertures.

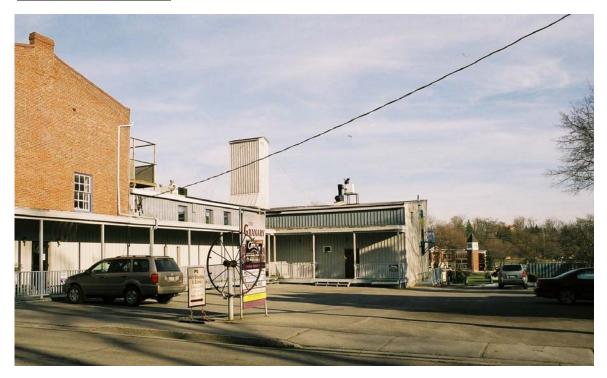
41 John Street (continued)

- Additions Premises are much enlarged by two-storey, pitched-roof, L-shaped board-and-batten-clad addition at rear and to south. Simple lean-to verandah provides access along south side of brick building and addition, returning along south projection of latter. Verandah is built with square-section posts and pickets and plain top and bottom rails. Eastern end of addition has unusual, tall, blank-walled tower with pitched roof, evocative of grain elevator and of unknown purpose. Large parking lot exists to south of brick structure and additions.

- <u>North elevation</u> of addition (at rear) has buff-brick wall sporting old Coca Cola sign (see Heritage Character Descriptions, Lent Lane), the latest of various signs to adorn this masonry.

- <u>East (rear) elevation</u> is two storey, also clad in board and batten, with small, square, single-pane windows. Extensive verandahs across rear have simple posts, newels, pickets and railings (as described above) and are an unobtrusive, semi-traditional presence on Lent Lane. Rear wall has assortment of signage while could benefit from some rationalization.

- Comments An attractive building, though with a number of recent elements. Shopfront, doors and transom window are obviously modern and could be more to heritage norms (especially doors), but are generally attractive. Shopfront pilasters and fascia lack suitable ornament and detail. Thickness of muntins in new 6/6 windows is somewhat noticeable, and metal frames of individual thermopanes tend to catch the light. See the Guidelines for comments on replacement windows. Window arches are generally sagging and may require support by concealed angle-iron. At rear addition, tower (assumed to have former industrial purpose, as would be fitting adjacent former railway line) and old Coca Cola sign at north wall are valuable heritage elements and should be conserved. For any proposed development of the large parking lot to the south, see the Guidelines. Note that this three-storey Georgian building is the last of its kind as one heads south on John Street and so marks the ultimate point of transition between Original Commercial Sector and Transitional Residential Sector.
