5.6 John Street, west side

50 & 52 John Street

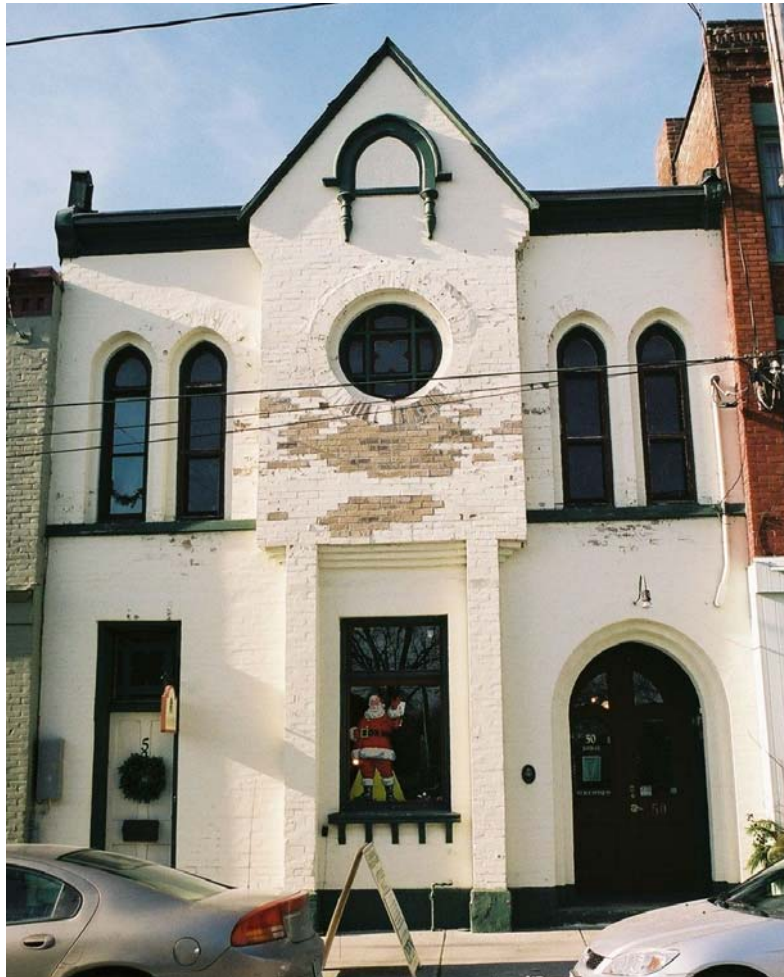
- Three-bay, two-storey, painted-brick Victorian Gothic building with upper oculus and wall-head gable (c.1874). Buildings **Designated** under the OHA, Part IV (Easement held by Ontario Heritage Trust).

- Description – Attractive, asymmetrical Victorian brick building has variety of eclectic elements. Brickwork is painted throughout (except in area of apparently recent repair) which, given style, may hide polychromy. Base of building is articulated by projecting courses with bevelled bricks at top course. Entry is set in large, slightly pointed arch at right, having multiple jambs and voussoirs, and band at flush hood-moulding. Doors are pair of tall, curve-headed wooden doors with two upper panes and single panel below. At central bay, rectangular aperture is set between narrow pilasters and has large single-pane sash under transom window. Projecting, canted wooden sill has five wooden brackets below, while wood transom above is plain. At LH side, aperture seems to be altered (voussoirs extend to right of jamb). Door to upper level is simple, four-panel door with bevelled-edge stiles and rails and flat panels. Transom window has old glass and unusual “gothic” wooden frame mounted within. At second floor, dominant element is projecting central bay, corbelled out to meet plane of pilasters below. Central bay contains large oculus within double voussoirs, again with flush hood-moulding. Oculus contains square central sash, with four-leaf inner motif, framed by segmental sashes. At either side, fenestration is pair of narrow, pointed-arch windows with original, two-pane casements under fixed transom windows, all over continuous, thick wooden sills. Apertures have double jambs and voussoirs, again with flush hood-mouldings. At gable, brickwork corbels out to either side, evoking mediaeval practices. Gable contains rendered, blind aperture in ornate, slightly pointed-arch, wooden frame, with unusual half-spindles below sill at either side. Eared wooden hood-moulding is evocative of flush hood-mouldings faintly apparent throughout building. At adjacent wall-head, deep wooden fascia with substantial cornice butts into decorative wooden brackets at either side of building. At gable fascia, trim consists of narrow profiled shingle-moulding.

- Comments; Front Building - This is an unusual and attractive Victorian Gothic building with many original elements. Recent repairs should be painted; or paint should be removed throughout. Paint, may well polychromy at flush hood-mouldings and perhaps elsewhere. Any further brick replacement should be done using hand-made bricks of suitable size and colour. Metal flashing should be removed at upper LH bracket. Lane Building - Located at rear of site, on Brewery Lane, fabulous old building is plainly visible and presents prime opportunity for enhancement of rear of property. Concrete block structure at west end might well be removed; or enhanced in appearance. Witnesses above suggest a demolished, pitched-roof structure here, which might be reinstated. Gable and south lookouts and rafter-ends should be repaired and a new (painted) fascia (and perhaps soffits) should be added. Chimney top should be rebuilt/repared, and west oculus requires repair and re-opening. Also, two window arches are collapsing at north elevation. Metal roof, which was rather rusty in 2003, has fortunately benefited from recent repainting, and should remain in good repair for many years.

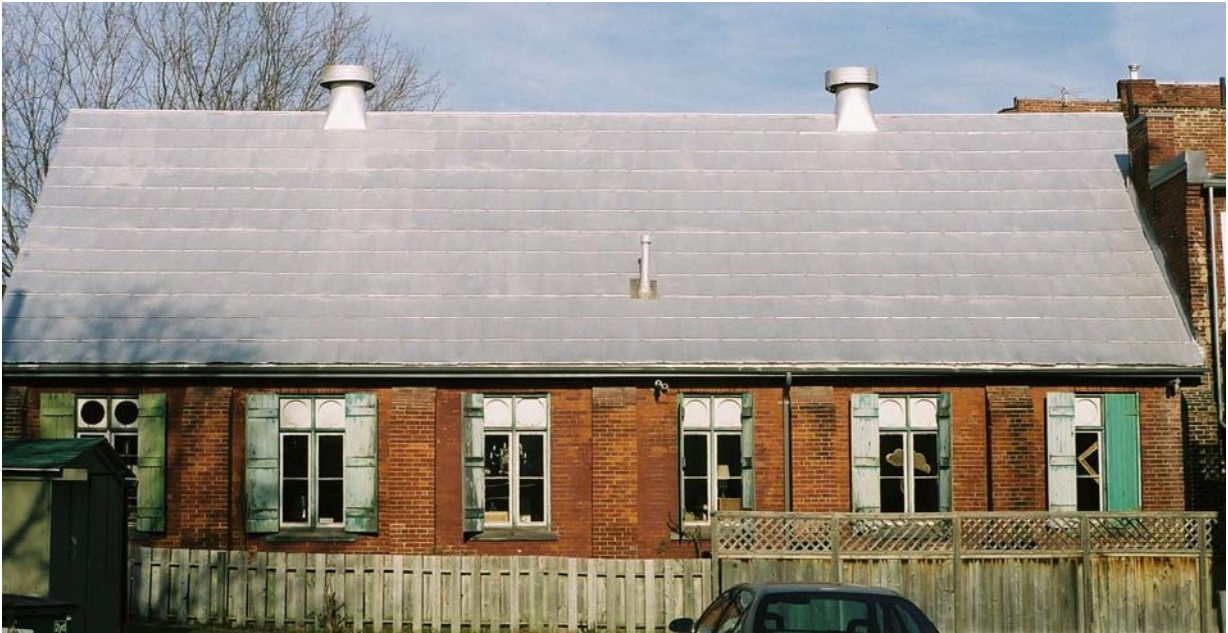
**50 & 52 John Street (continued): South Elevation at Brewery Lane**

- Lane Building – Six-bay, buttressed, red-brick building with steeply pitched roof clad in galvanized sheet-metal panels, and with two large metal ventilators at peak (former Orange Hall, c. 1850).

- Description – At north and south elevations, large, hall-type structure is one storey high, built of load-bearing, hand-made, red-brick masonry with row of headers typically every seventh course. Robust and simple buttresses end with canted upper brick portions tucking under simple eaves. Within each bay is pair of tall, two-pane casement windows separated by wooden mullion, all over thick wooden sills. Mullion extends through transom, with glazed oculus either side (now mostly painted over). Shutters flanking all windows are made of narrow, v-jointed boards braced by three horizontal rails fixed at inner face. At east gable wall, crude, concrete-block lean-to addition is set below unaltered red-brick masonry. Lower, central area contains intriguing, gabled projection which appears, complete with projecting brick course below brick coping, typical of a gable-wall parapet. High-level oculus is boarded up, possibly with louvred vents behind. Brick chimney to left appears to have been truncated just above roof level. At gable, lookouts project from building within and are unprotected, i.e. without fascia. Roof is clad in unusual, long and relatively narrow sheets of corrugated, galvanized sheet-metal, recently painted with suitable, zinc-coloured paint. Original roofing material may have been similar, industrial roofing; or this may even be original. Two circular metal ventilators at roof peak top building which is a mixture of both old traditional and old industrial materials and aesthetics.
