5.6 John Street, west side

86 John Street

- Imposing, three-storey, Victorian buff-brick palazzo, with fabulous, metal window entablatures (1857). Former Bank of Upper Canada, apparently by F.W. Cumberland, is **Designated** under O.H.A. Part IV.

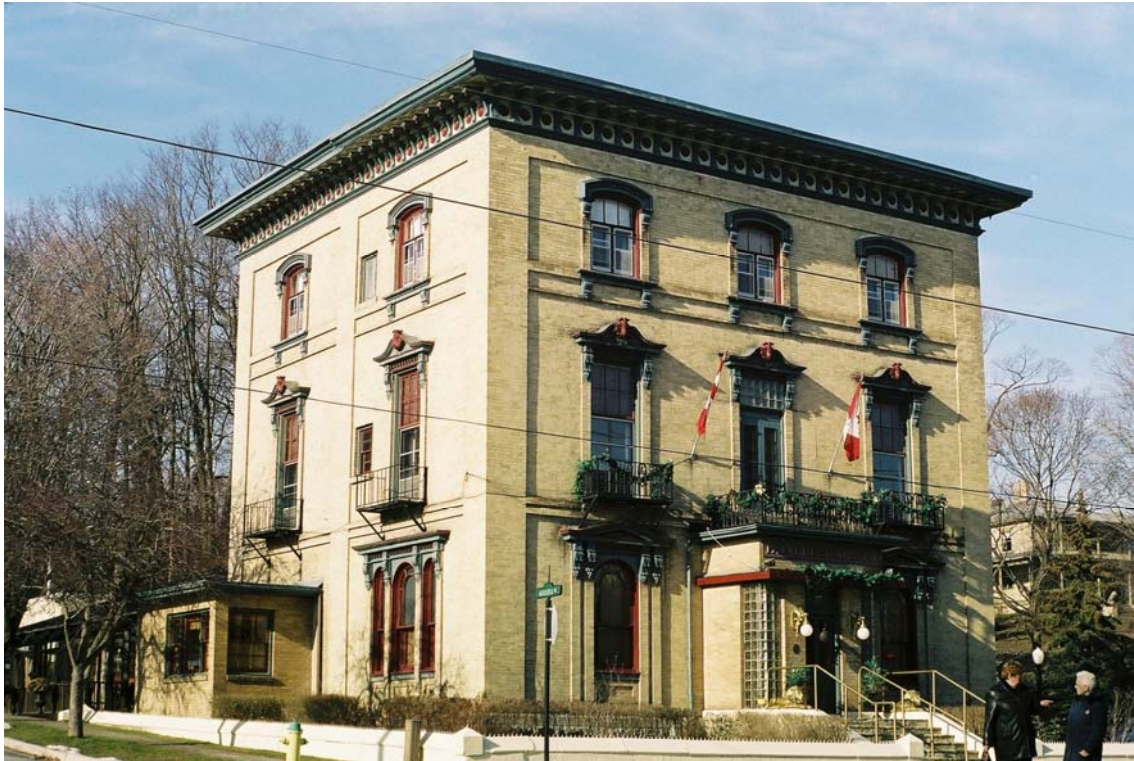
- General Description – Towering Victorian corner house has main 3-bay façade towards John Street, and similarly decorated, 2-bay elevation to south. Property is enclosed on two sides by low stone wall built of local rubble stone (now rendered and painted), with triangular-section, ashlar copings having inset spikes at approximately two-inch centers along top. (An old photograph in exists which shows the original, ornate cast-iron railings). Building masonry is of buff brick laid in Flemish bond throughout, built off limestone plinth with bevelled upper edge, set on local, coursed-rubble limestone foundation. Pair of bold brick stringcourses articulate each of floor levels above.

- Front Elevation, Vestibule – Symmetrical front façade has palace-like aspect, with buff-brick vestibule reached by broad stair and landing now clad in rustic limestone pavers and with plain brass railings at center and sides built into stone copings. Vestibule is c. 1950s addition comprising two brick piers, curved glass-block corner panels and simple, painted metal cornice above. In contrast to fifties theme, front door is recent but traditional in style, with two round-headed windows over two vertical panels. Transom window is blocked with plywood bearing address of property. Buff brick above, laid in common bond, is also assumed to date from 1950s, with simple boarded soffit and plain wooden fasci, the latter supporting traditional ogee gutter leading to corrugated downspout. Small balcony above, however, has period cast-iron railing with ornate corner posts with finials (original assumed to be at LH side) and balustrade of iron panels with round-headed arches housing various decorative elements.

- Front Elevation, Ground Floor – Ground floor has round-headed apertures either side of vestibule, with double-hung windows having taller upper sashes; both sashes having peripheral panes within vertical muntins set some 6” in from sash styles. Windows are framed by paired, narrow brick pilasters built off modest bases. Recessed brick spandrel panels exist below rounded wooden fascias and sills. Pilasters rise to pedimented, Beaux-Arts, cast-iron entablatures supported on paired brackets cast in form of stylized foliage, each bracket having double leaves over large acanthus. Entablature comprises band of multiple dentils spanning between brackets, with cladding below concealing voussoirs of arches. Low-pitch, triangular pediments have bead-and-reel ornament at upper edge.

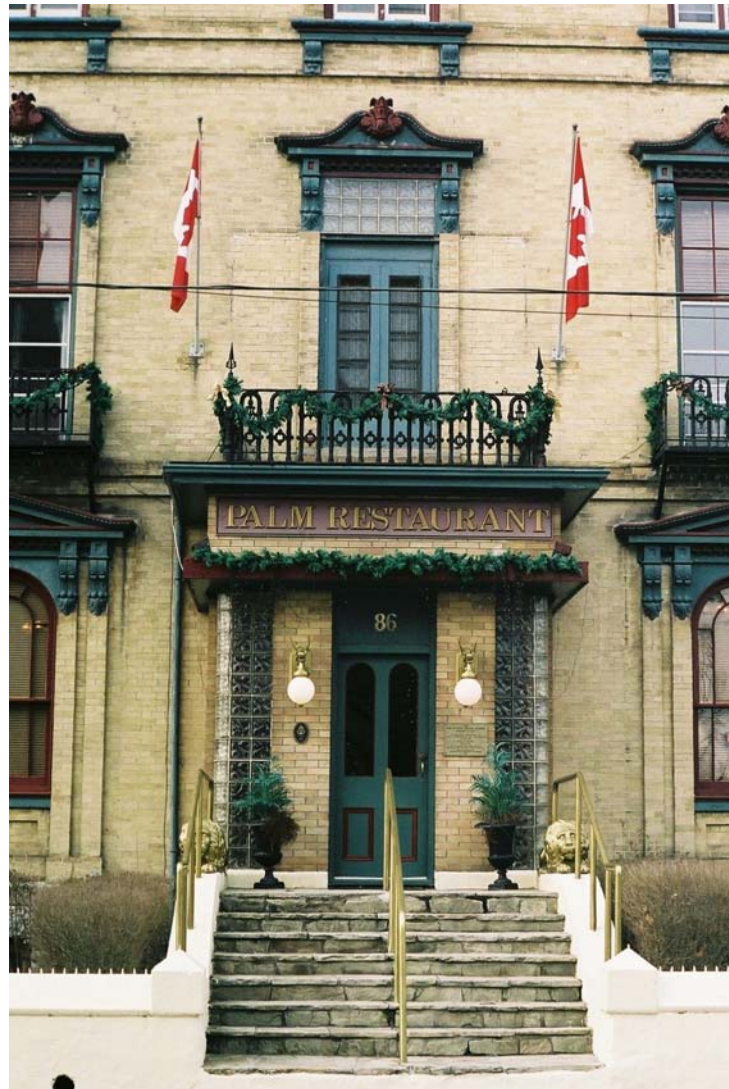
- **Front Elevation, Second Floor** – Second-floor fenestration is variation of that described at ground floor. Three symmetrically placed apertures have single pilaster at either side, rising to single iron brackets and pediments as described, though here with scroll-type or Chippendale pediment having central wheat-sheaf-type ornament with small fleur-de-lis above. Windows are combination of (at right) original 6/9 (with metal storms), (at left) six-pane sash over two-pane casement windows (with metal storms), and (at centre) pair of five-pane French doors (with wooden screen doors) and more glass block above. Outer windows have small metal balconies with iron balustrades as over vestibule.

- **Front Elevation, Third Floor** – Top Floor has windows framed by brickwork as at second floor, but with differing trim. Metal sills have robust rolled edge and profiled fascia below, and are supported by iron brackets cast with typical foliage pattern. Brackets span between upper and lower band-courses near floor level. Entablatures are segmental-arched, dropping at sides to modest moulding set above brackets similar to those below sills. Entablatures are decorated with fine, classically-derived leaf motif framed by roll mouldings. Windows at this level have three-pane, segmental-headed transom windows with (apparently altered - see old photograph) windows below being pair of 1/1 sashes with central mullion in each aperture (behind metal storms).

- **Cornice** – Impressive, Italianate wood cornice is over modest metal cornice crowning masonry. Frieze has closely spaced, fluted scroll-type brackets with roundels between, while soffit has similarly shaped modillions with small pendant finials and plain coffers between. Cymatium has wide *cyma recta*, which is somewhat obscured by deep metal flashing above. Flat roof is invisible from street.

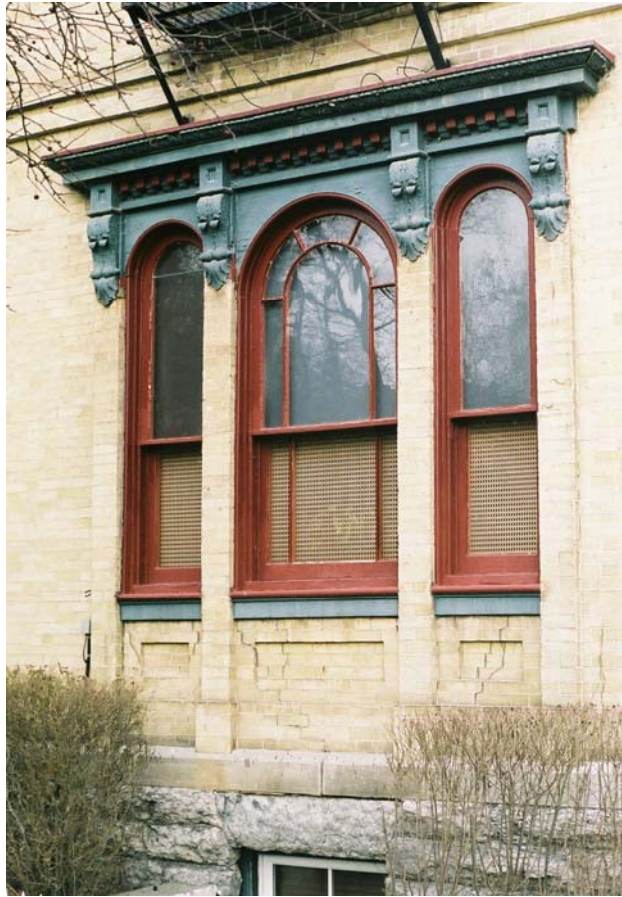
- **South Elevation** – South elevation generally has elements as described at front, but is separated by central pilaster into two bays. **Ground floor** - Ornate window at RH side is divided by narrow pilasters and has recessed brick panels in spandrels below. Window comprises three, round-headed lights with wider central unit having sashes as at front, with inner muntins forming smaller peripheral panes. All units are double-hung, with taller top sashes having textured, translucent coloured glass. **Entablature** above comprises elements as at front; pilasters rise to cast-iron entablature supported on brackets cast with stylized, scrolled foliage. Entablature has also band of multiple dentils spanning between brackets, over painted cladding which conceals voussoirs of arches below. Continuous corona is crowned by *cymatium* embellished with classical, leaf-type motif, with (rusty) metal flashing above. **Upper Floors** have entablatures, doors and windows as at front elevation, with differences as follows: second floor has plain metal balconies and two small windows inserted to right of central pilaster - 2/2 at second floor and casement at third - both with concrete sills and angle-iron lintels. Mouldings at top cornice fascia change dramatically near center of building, with flashing above also varying.

- **South Addition** – Modest, one-storey, flat-roofed brick addition at southwest corner has brick sills and headers on hidden lintels and 2/2 windows with horizontal muntins (c. 1950). Large pitched-roof addition (2006) beyond is largely glazed at south side and encloses former patio.

- **North Addition** – Post Modern, glazed, framed verandah fronts deep one-storey buff-brick 1950s wing.
- **Comments** – An ornate and impressive building in good repair, with various alterations and additions which do not generally detract from appearance of the original. Removal of 1950s elements at front porch would be unfortunate, though perhaps justifiable. Other additions are more expendable, but less obvious. Later windows at upper south elevation are unobtrusive. New pitched-roof addition over former patio is sympathetic to the overall building. At wall on SE corner, painted coping and render below do not reflect original finishes, and might be removed if desired. Similarly, cast-iron railings might one day be reinstated. Any development of parking lot should be discouraged if this intrudes on building.
