5.1 Queen Street, east side

7, 9 and 11 Queen Street

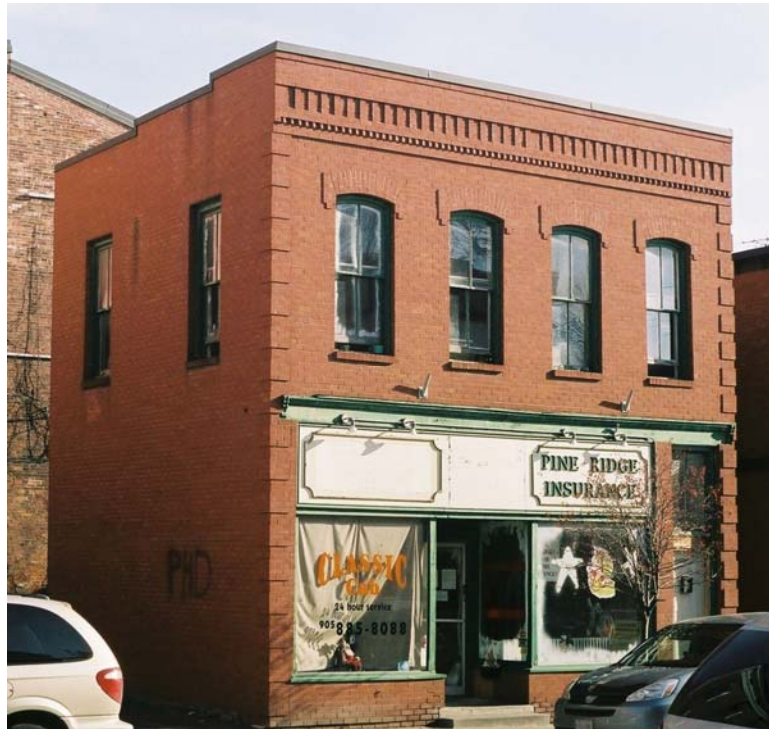
- Two-storey (re-faced) red-brick building with period fascia and end-brackets, and original, segmental-headed 2/2 front windows (c.1875). **Designated** under the OHA Part IV.

- Description – Re-faced, red-brick, common-bond façade is assumed to replicate original façade, though perhaps in somewhat flattened form. Commercial ground floor has two, symmetrical shopfronts either side of recessed central entry. Piers at either side have quoins in groups of four projecting bricks separated by two recessed courses. Stall risers are also in brick, while window frames and corner posts above are old, with bevelled edges and stop-chamfers typical of such elements. Central entry has wide stone step and (unusual) exterior hardwood flooring beyond. Door to no. 7 is modern, aluminum-framed glazed door, and entry to no. 9 is modern, 6-panel metal door. At upper shopfront, deep plywood sign may conceal older transom windows behind. Shopfront fascia, with small brackets at either end, has beaded lower edge and modest ogee-cornice above, and is recessed into new brickwork. At extreme RH side, door to upper floor is within narrowed aperture, under tall, old 2-pane transom window with original glass. At second floor – Red-brick quoins continue, with common-bond brickwork between. Windowsills are built of rowlock headers (in contemporary manner), while much original glass remains within 2/2 windows with curved top rails. Projecting red-brick voussoirs at segmental arches drop to single, central corbelled header below. Parapet has slightly projecting lower band-course two-bricks high, then single dog-toothed band, two additional plain courses, and then a band of stacked headers with small, recessed panels between, spanning full width of building. Parapet concludes with several brick courses rising to projecting course, and pre-finished metal flashing above.

- North side of building is re-bricked as described, and contains two new 2/2 old windows, with flat arches and steel lintels, at upper floor. Courtyard-type space in this area is attractive, with variety of buff and painted brick and old windows and doors at rears of adjacent buildings on Walton Street.

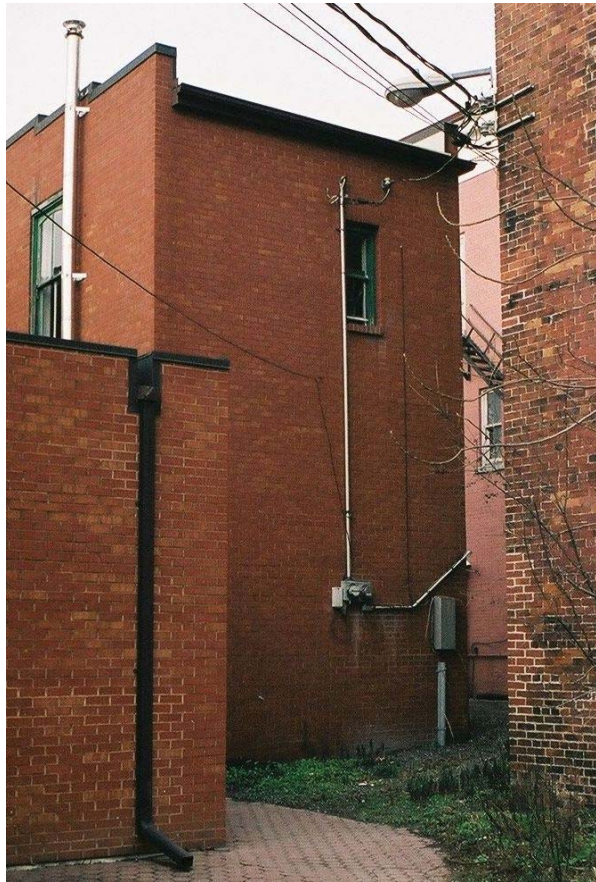
7, 9 and 11 Queen Street (continued)

- South Side and Rear Elevations – South side is plainly visible from east, and boasts an unusual combination of old 2/2 window with segmental-headed glazing, set within a new rectangular aperture with steel lintel above. Rear elevation is also plainly visible from Ganaskara River and Trail, and contains one old 1/1 window at upper level, again within new masonry, with rowlock header sill and steel lintel above.

- Comments - Building is an attractive presence near to Walton Street, with re-bricking (in metric brick) being unobtrusive; except at upper level sills, which is not a period detail. Old windows remaining at upper level in various elevations (as described above) are a real asset and should be re-puttied and re-painted to protect them. Shopfront sign should be reduced in height, especially if exposes older upper glazing behind. Brick stall-risers (which require repointing) are atypical of the Heritage District, as is aluminum-framed central door, and recent door to upper level is also unsuitable. Various possibilities exist for attractive rear or side terrace or courtyard, set adjacent the historic rear elevations on Walton Street – or at least an improved passageway to the north of this building – and such possibilities should be explored. Rotary Walkway, along the Ganaraska River, provides an increased opportunity for pedestrians to experience and benefit from such interesting spaces.
