5.6 John Street, west side

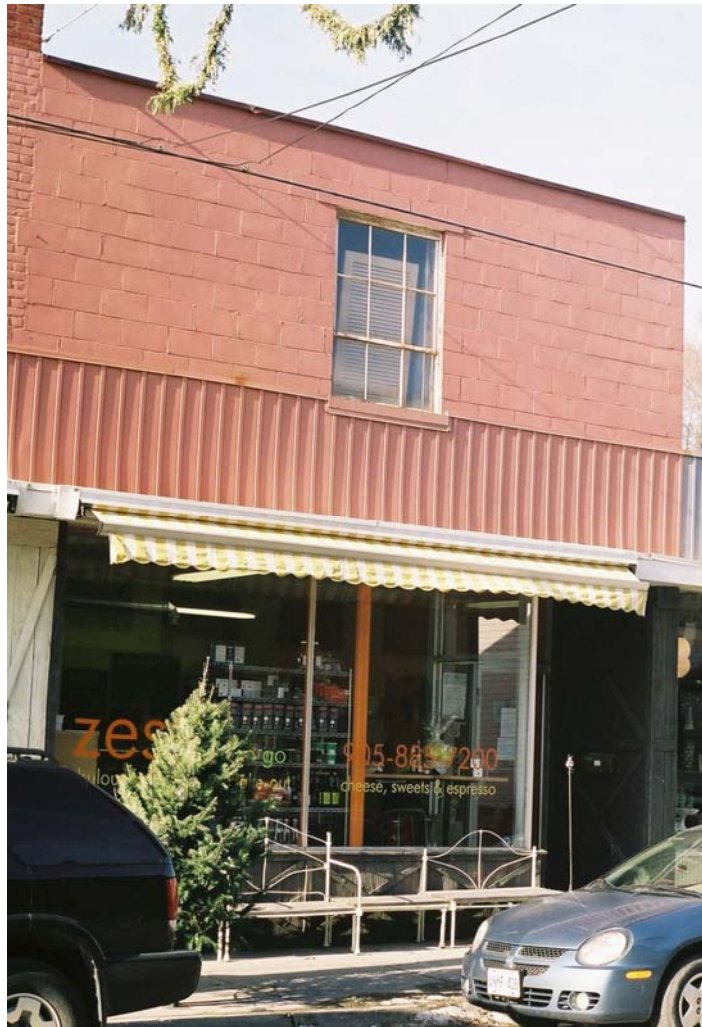
**64 John St.** (middle)

- Modern, two-storey commercial building with painted, concrete-block upper floor (c. 1960).
- **Description** – Recent structure is out of keeping with street in form, scale and materials. Adjacent pavement, base of wall is clad with rustic vertical boards with apparent cross-bracing, providing a sharp contrast to the huge aluminum-framed windows above. Windows and door have standard aluminum-frames, with typical modern glazed door recessed at RH side. Retractable, striped white-and-yellow awning above is an attractive feature. To right of door, in recess, is additional area of rough vertical boards with upper and lower cross-bracing. Area of traditional fascia and cornice is finished with deep band of painted, ribbed sheet-metal. Window signage is similar to adjacent shop to north (which has same occupancy), but although modern in style, is slightly smaller here than next door. At second floor, painted concrete block is obviously recent, though tooting-in at LH side and metal-frame, 6/3 window suggest this may be an older structure, with original cladding later replaced in concrete block. Window sill is concrete, lintel is metal angle, and parapet has thin metal flashing.

- **Comments** – Aside from (modern) awning, this is not a building in keeping with historic, commercial buildings of John Street. As noted, upper floor (and therefore building) may be older than this seems and this aspect deserves some investigation. Alignment of window head with those at number 64 John Street (south) may be significant. If upper floor is recent, then two additional floors might replace this, with fenestration typical of rhythm on the street, all as per the Guidelines. This would probably imply an entirely new building. In the meantime, the paint on the concrete block mitigates its natural appearance, and the metal-framed window is an anomaly which may have interesting story behind it.
